REPAIRING THE EXISTING OLD CONCRETE STRUCTURES BY APPLYING MODERN METHODS AND NEW MATERIALS RIPARIMI I STRUKTURAVE TË VJETRA PREJ BETONI ME METODA DHE MATERIALE BASHKËKOHORE

NASER KABASHI, CENË KRASNIQI

AKTET IV, 2: 336-342, 2011

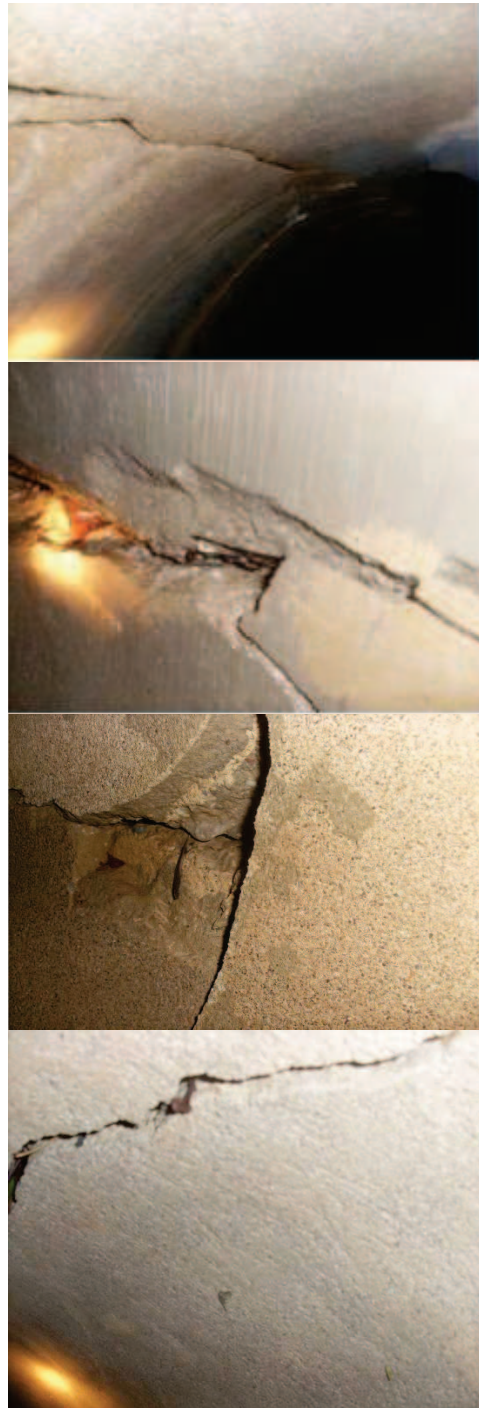
Pictrre 1. The channel condition at the time of the assesment

The shape of the channel is an ellipse form with a height of ~ 1.20 m. The carrying capacity of the channel, with these dimensions, cannot withstand the design capacity. The impact of loads has caused very big cracks as can be seen in the picture above. Some segments are heavily to completely damaged from the lateral and above load as a result of the impact of slope dirt to the channel itself. Sources of grave concern were a number of segments where joints were not functioning due to considerable displacement of the slabs. The channel was built in 1939, when the inside surface was plastered manually.

The most adverse elements are the cracks, respectively the division the slabs from the wall, which causes loss of water or make it dysfunctional. This assessment state is done to evaluate and to undertake the following steps.

- Removing damaged parts, i.e. non quality concrete
- Cleaning the surface
- Injecting the cracks in considerable depth
- Water stopping from flowing in place where are the water loss
- Repairing the channel surface with polymer materials

- Injecting in certain places in deeper distance
- Repairing the surface with polymer based materials

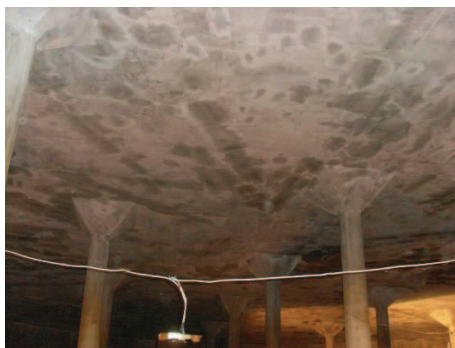
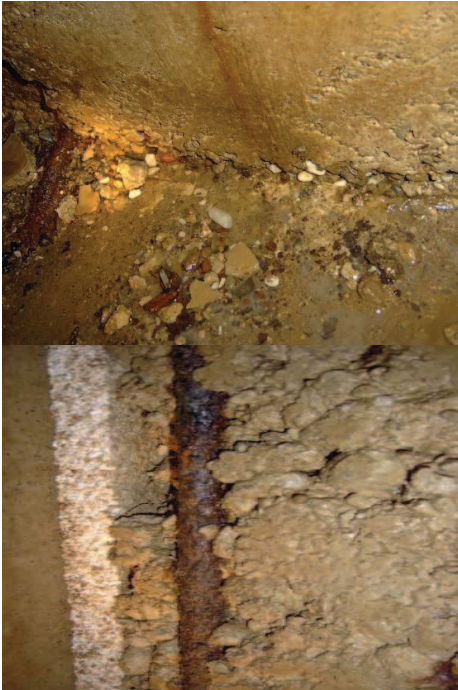
Picture 2. Conditions of the structure during the evaluation moment

- Evaluation of the existing state of structure
Major water loss happens as a consequence of segregated concrete in some parts that caused significant water leaks. But the most important elements that caused the loss of water are cracks between the tank slab and walls in many parts of perimeter of structure. Consequence of the lack of maintenance for a long time is also the corrosion in some parts of concrete structure, as well as in the steel tubes inside the water tank that are used for taking the water from the tank to the distribution.[1, 4].
Recommendations in this structure are in direct connections with followed steps:

- Cleaning the concrete surfaces
 - Removing damaged concrete pieces with high pressure water
 - Stopping the water leaks
 - Injection in perimeter of water tank, especially in the connection between the slab and the wall

- Protection the reinforcement steel from the further corrosion

- Protecting the concrete structure in segregated places with appropriate plastering with polymer materials.

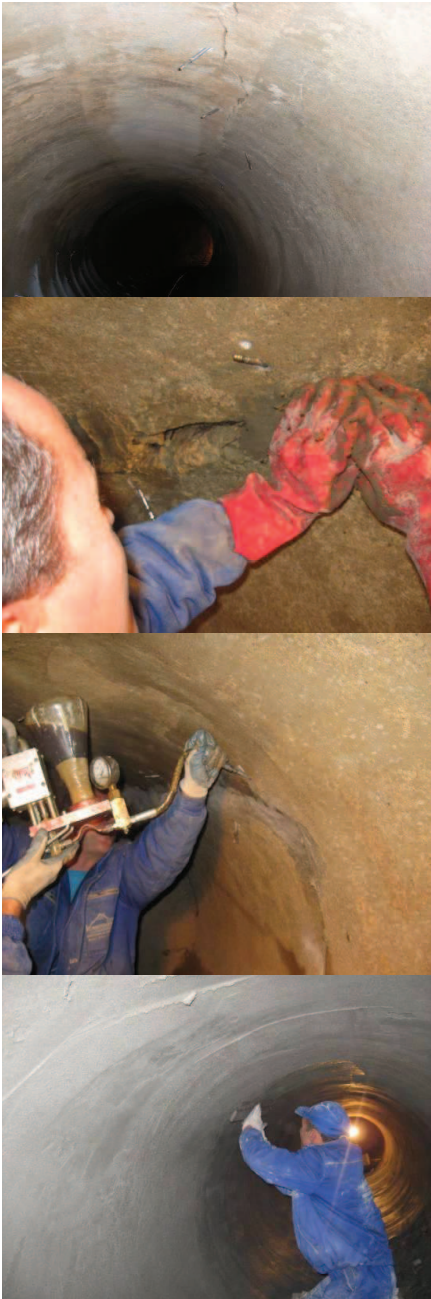
Picture 3. Phases of executing of the work in derivation channel

The quality of the concrete shows that expect in some places where damages are evident, there aren't any damages in structure. This was a facilitating circumstance which allowed us to apply the injection method in repairing the cracks that were quit big dimensions. The injection method is followed by internal expanding forces which require sustainable structure in cases of major cracks as they were present here.

In places where cracks were very big dimensions, there was used preparatory method which requires specific materials, that is known as the method of leak closure. Using this method we managed to eliminate the big leaks, which result with water loss while flow through the channel. Injection method is interlinked with a special technology which requires certain equipments and materials. Mainly these equipments are pumps with relatively high pressure, and the material is quite liquid, and also performs movement of material through the gaps and when it stops it results with expansion and fills the gaps.

The injectors are placed in mechanic way in wholes prepared before, and their position is depends of filling the structural cracks during the process.

The repaired parts then in next step are plastered in large area of surface in order to provide protection of repaired parts as well as the

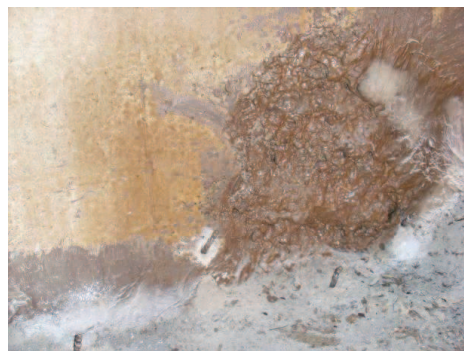
Picture 4. Water stops leaks with quick hardening materials

Fast and huge amount water streams occur frequently in facilities like water tanks. Applications of quick hardening method which is followed by expansion is very efficient because the hardening becomes effective within 30 seconds and the water is stopped. In general the material contains polymer and accelerator such as additives for quick hardening, as it is shown in literature or in this practice case. [2], [3], [7]

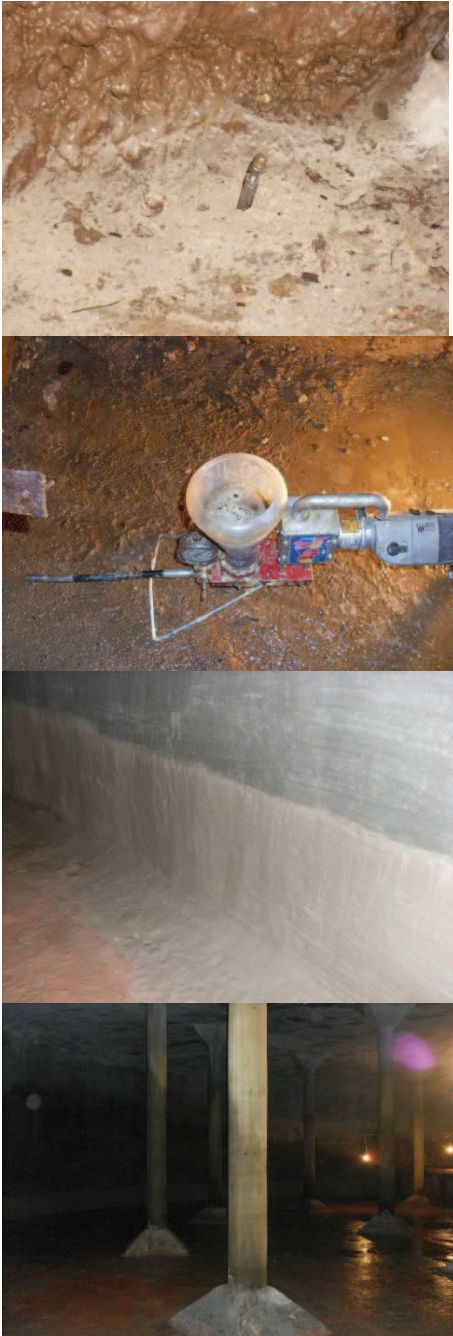
Picture 5. Repairing steps in the water tank

Application this quick method are creates precondition for creating appropriate surface for the next step which is placing injectors and application the injecting method in most parts of perimeter, and in this case to create a “knitting-connection” between concrete slab and wall. This method and the steps of application are presented in following photo.
